Flood Hazard Assessment Report Bellvue, Larimer County, Colorado

Purpose: The purpose of this report is to summarize the findings of our (NRCS) site evaluation in Bellvue Colorado and the surrounding area in relation to potential flooding that might be expected in the Mill Canyon watershed following the High Park fire.

SITE PLAN
 BELLVUE FLOOD PROTECTION RECOMMENDATIONS
 HIGH PARK BURN AREA
 LARIMER COUNTY
 COLORADO

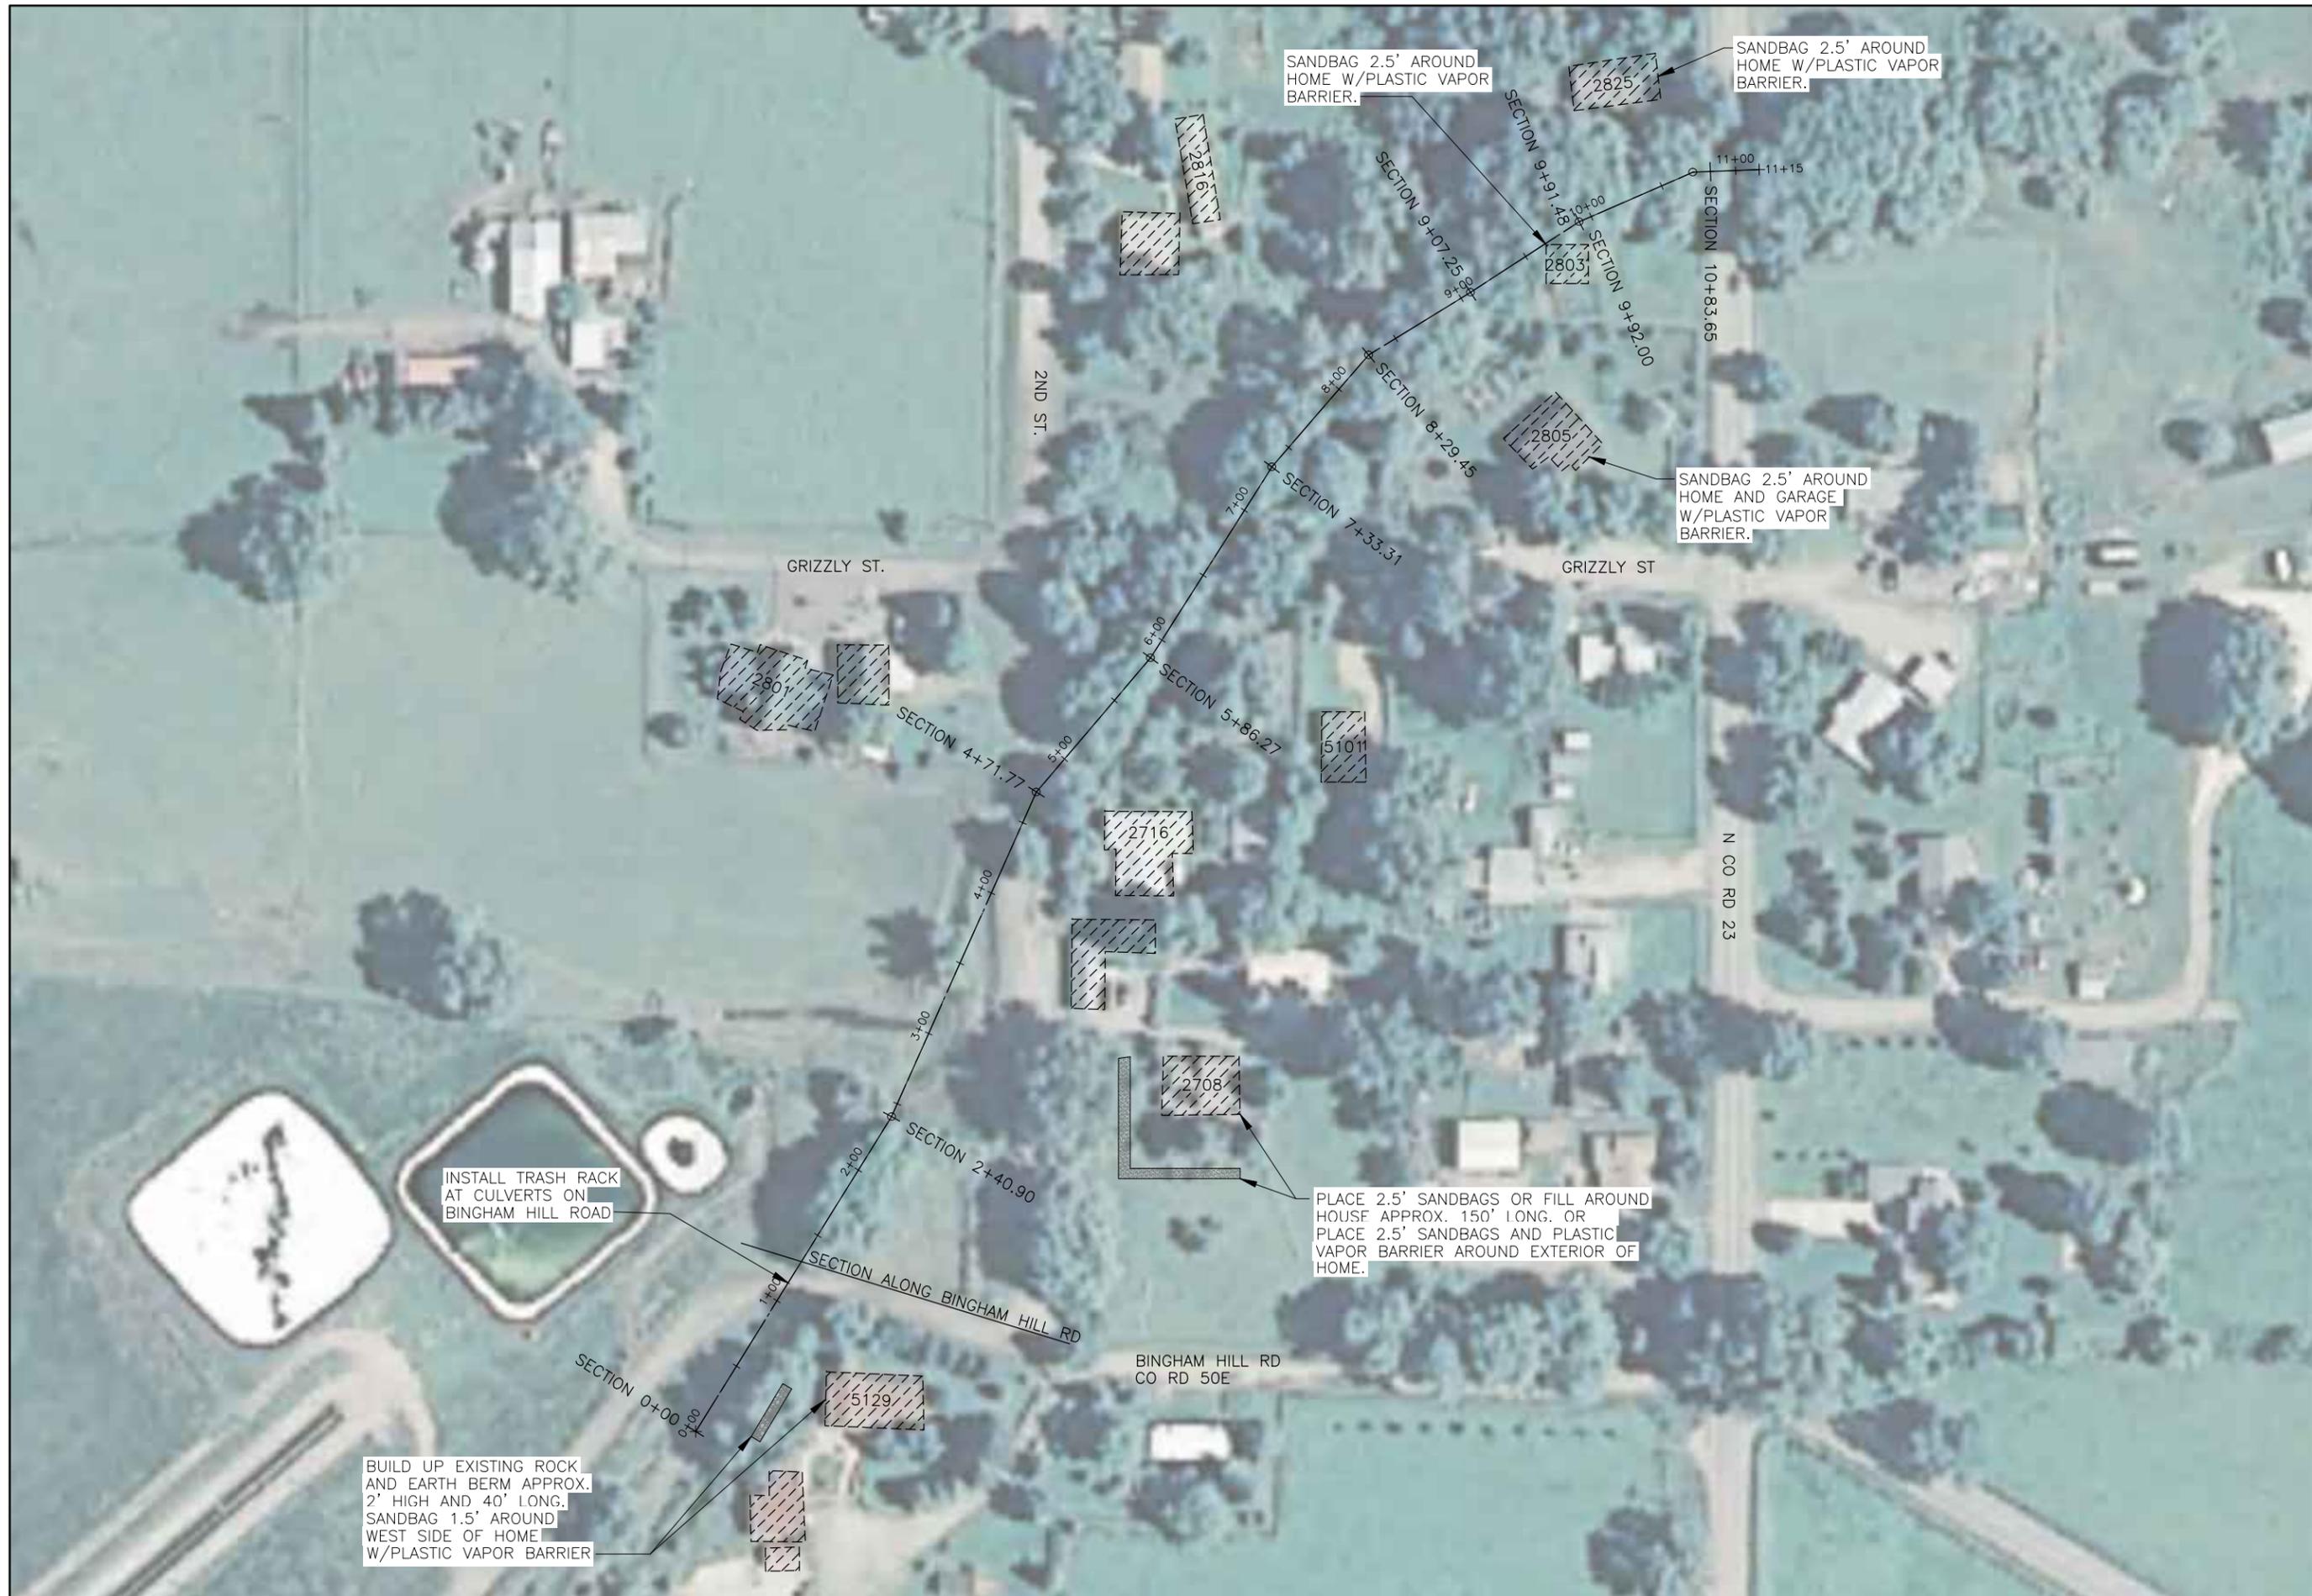
Assets and Resources at Risk: The large culvert under County Road 25E is capable of passing about 500 cubic feet per second (cfs). This culvert is subject to being blocked or partially blocked by debris. The 2, 4' diameter culverts on County Road 50E, Bingham Hill Road, near the fish hatchery are capable of passing about 125 cfs. The culvert under County Road 23, an oval 3'x 4', has less capacity. The 25 year-1 hour storm of 1.8 inches is predicted to produce peak flows of 1300 to 1500 cfs, far greater than the capacities of any of the culverts. All of these county roads will be overtopped at these crossings. Overland flow will cross County Road 25E north of the crossing. All the culverts are subject to being blocked or partially blocked by large woody debris. There are seven residences potentially at risk of flooding in Bellvue (see Site Plan).

The team surveyed several profiles through Bellvue and upstream to the Krist Ranch (see Site Plan). Hydrologic data developed using post fire conditions were used to estimate flooding potential along the creek at the profile locations using the 25 year-1 hour flood event, 1.8 inches of rain in 1 hour, estimated to produce a flow of 1500 cubic feet per second (cfs).

Recommendations: Construct debris control structures upstream of the large culvert under County road 25E and on the State Fish Hatchery property at the location shown on the Site Plan. A debris rack 12 foot wide should be installed for the culverts at the Bingham Hill Road crossing.

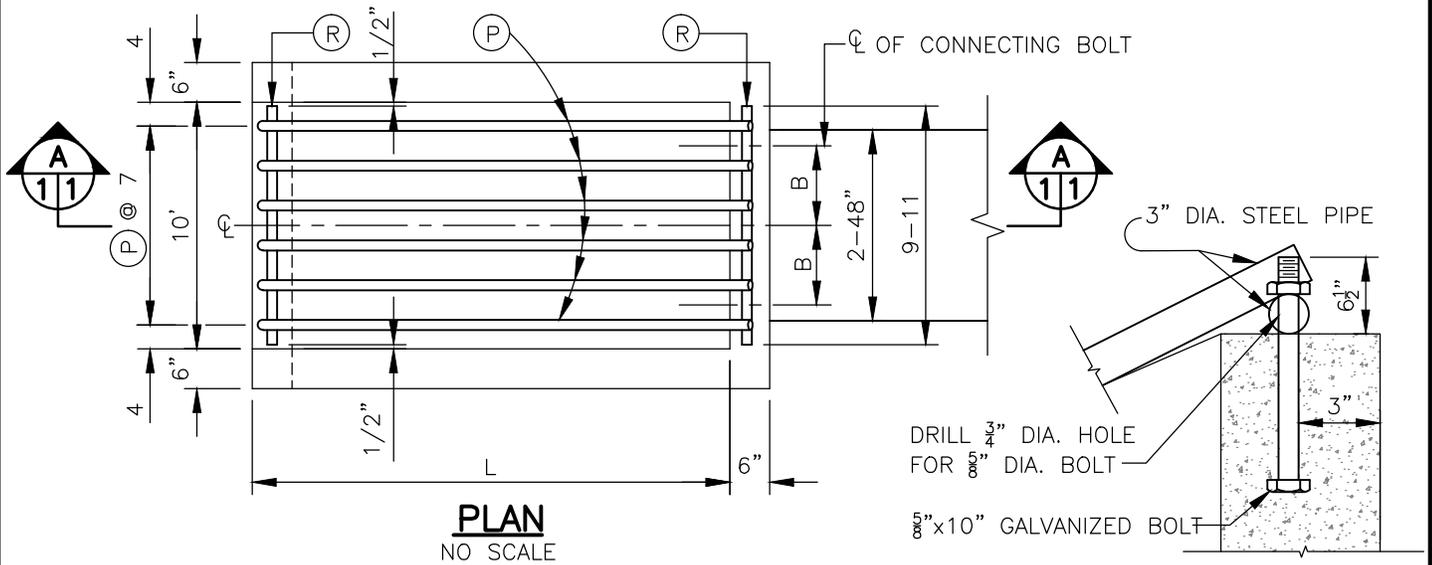
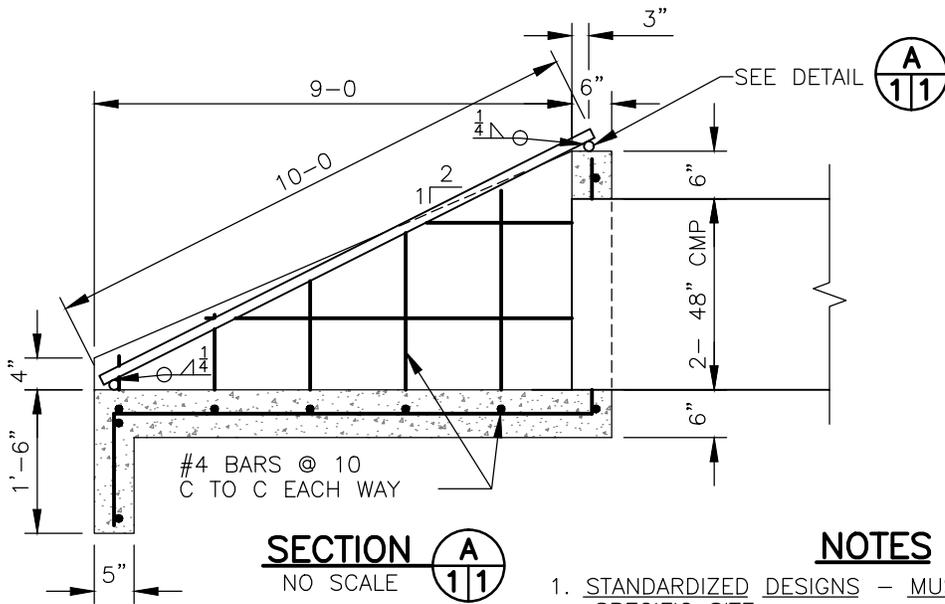
**INLET AND TRASH RACK
DETAIL**

DETAIL A
NO SCALE A-11
