Flood Hazard Assessment Report
Boyd Gulch, Larimer County, Colorado

March 6, 2013

Purpose: The purpose of this report is to summarize the findings of our (NRCS) site evaluation of post fire conditions in Boyd Gulch (along Kings Canyon Road) south of State Highway 14.

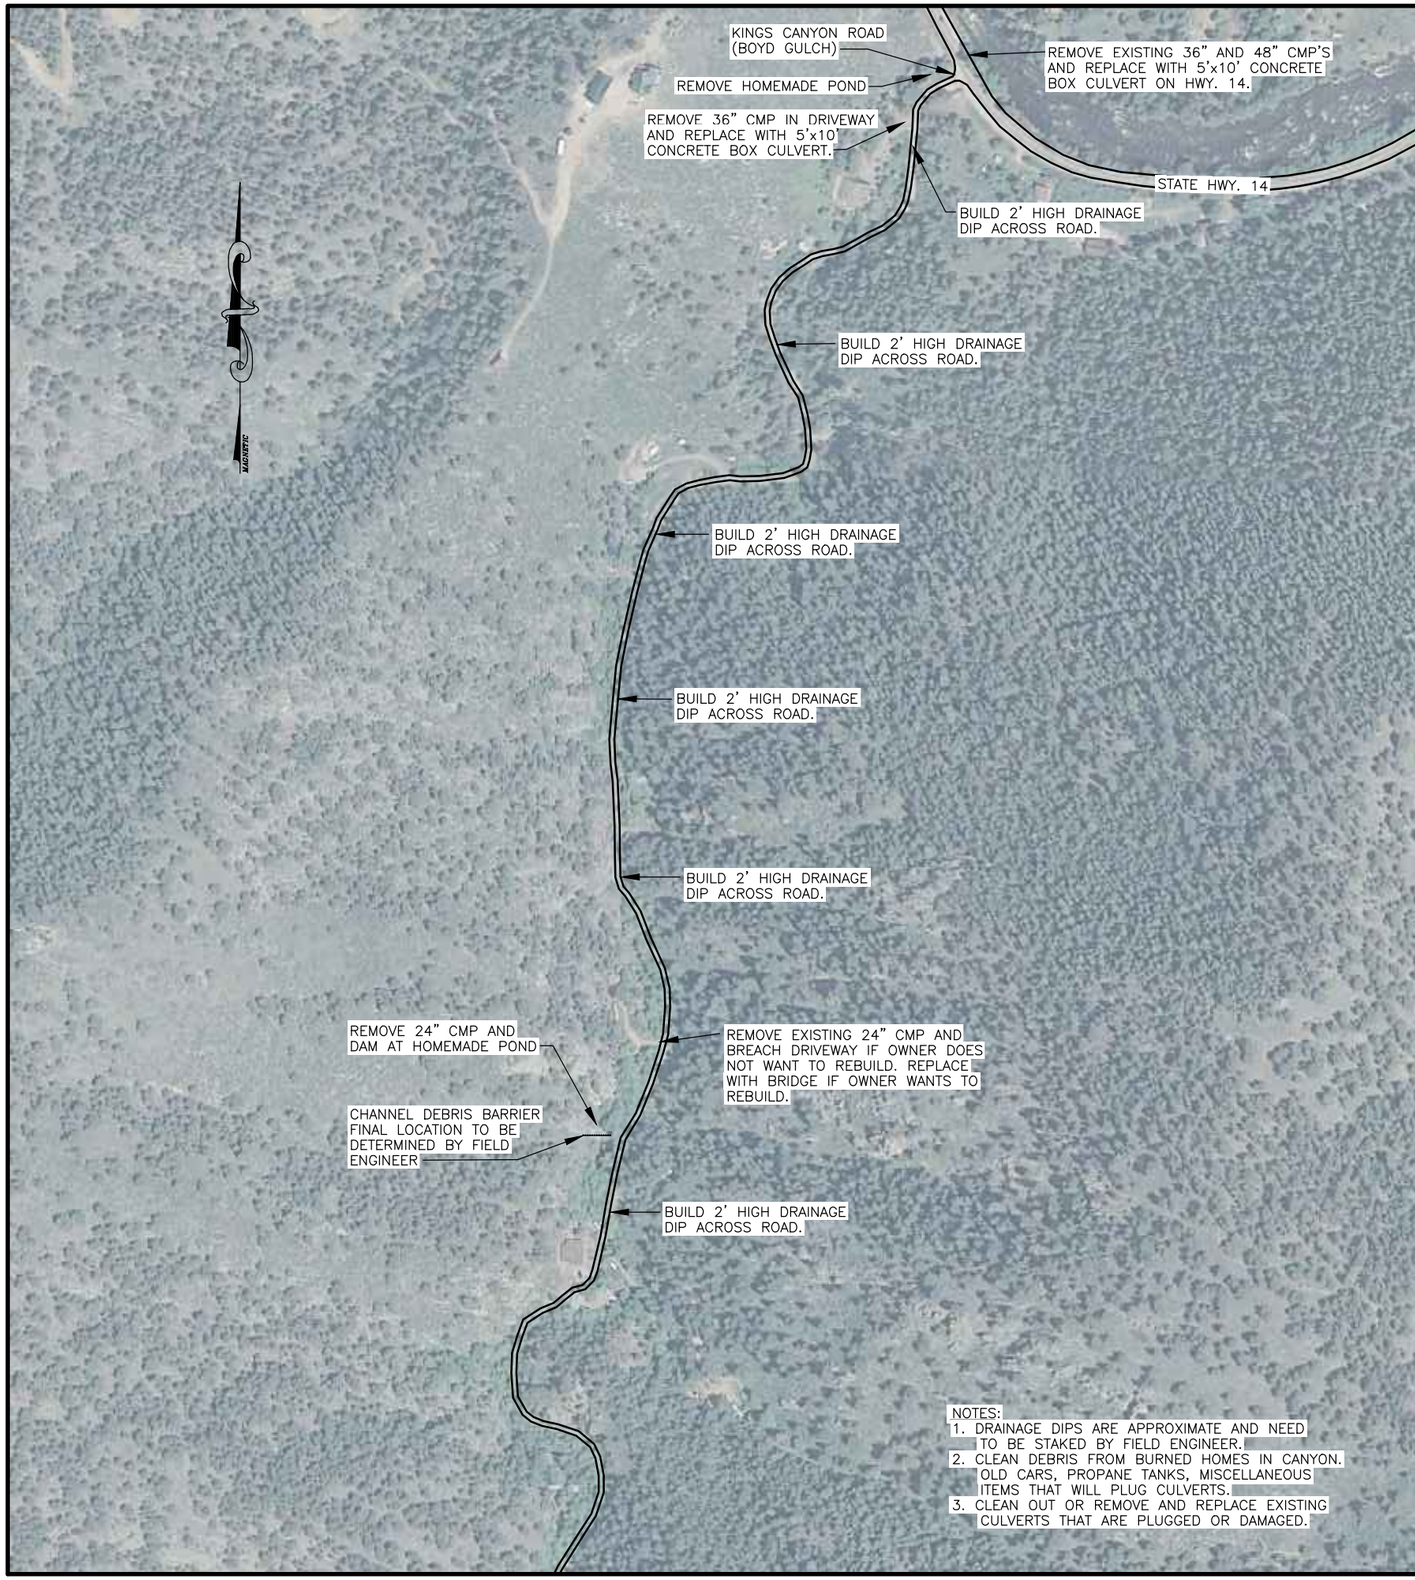
SITE PLAN
CHANNEL DEBRIS BARRIER CROSS SECTION

NOTES:
1. DRAINAGE DIPS ARE APPROXIMATE AND NEED TO BE STAKED BY FIELD ENGINEER.
2. CLEAN DEBRIS FROM BURNED HOMES IN CANYON. OLD CARS, PROPANE TANKS, MISCELLANEOUS ITEMS THAT WILL PLUG CULVERTS.
3. CLEAN OUT OR REMOVE AND REPLACE EXISTING CULVERTS THAT ARE PLUGGED OR DAMAGED.

Recommendations: Construct debris structure in the area described on Site Plan drawing. Remove the dam and the 24" CMP culvert in where debris structure is to be built. The debris structure should be constructed in the footprint of the dam since that ground will already be disturbed. Leave the pond berm along the road to protect the road and contain debris in the channel. Construct a drainage dip at the crossing just upstream of the existing pond to direct out of channel flows back into the channel. Remove the existing 24" CMP culvert and breach the driveway access to the property just north of where the debris structure is to be built. If the property owner wants to rebuild, a bridge should be constructed. Build 2' high drainage dips across road to force water back into creek. Location of these drainage dips will be staked by the field Engineer. Remove the existing 36" CMP culvert at the first house on Kings Canyon Road and replace it with a culvert of similar capacity to the culvert installed under Highway 14. Clear the channel of debris from the driveway to Highway 14. Water needs to be kept in the stream and off of the road as much as possible. This canyon is narrow and has many choke points that will force water onto the road. The stream channel needs to be cleared of debris and the existing culverts need to be kept clean or replaced if damaged. Debris from burned homes should be removed from canyon.

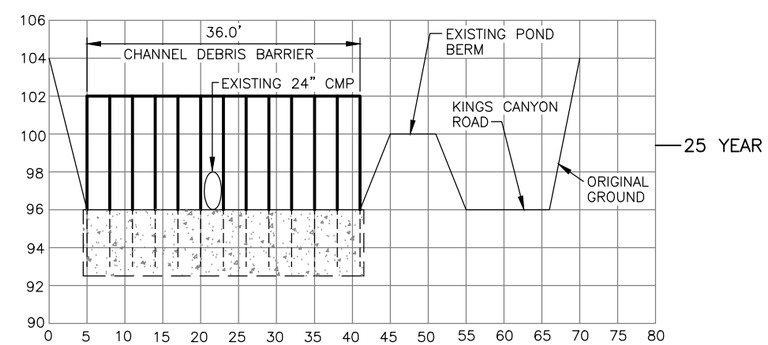
SECTION ALONG DEBRIS STRUCTURE AND ROAD
(CHANNEL DEBRIS BARRIER LOCATED IN EXISTING POND AREA)

Investigative activities: Hydrologic data developed using post fire conditions were used to estimate flooding potential along the creek using the 25 year-1 hour flood event, 1.8 inches of rain in 1 hour, estimated to produce a flow of 610 cubic feet per second (cfs). Our team hiked up the canyon a little over a mile from where the road becomes impassable. Many of the culverts were buried and undetectable, we could not tell if they were there or not. There were burned out cars and trailers along with miscellaneous debris from the burned out homes. Many areas of the canyon are so narrow that the road is the only option for the stream to overflow onto. Our team thought a debris structure
